## ***Ingenuity and Persistence Leads to Innovative Solutions and Cost Savings***

Extrusion Screen

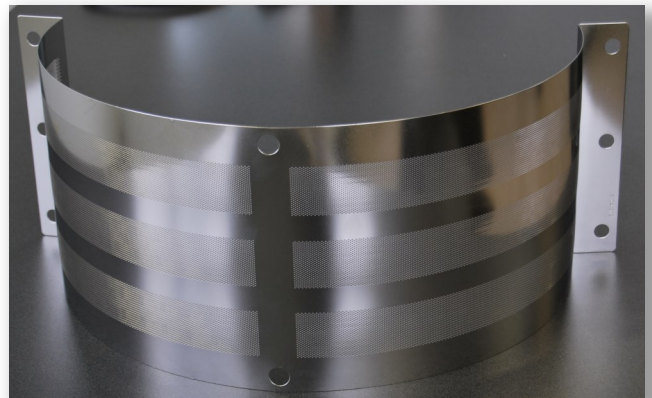
*Extruder screen that was developed by Hendrick in Elgin, IL. Made of 22GA 304 stainless steel perforated with 0.9mm/0.0354" holes, the manufacturing team developed a way to reduce the recommended industry practice of perforating a hole diameter 1.5 times bigger than gauge thickness.*

The extrusion screen would need to be a workhorse, withstanding the constant flow of abrasive material forced through the holes. Further, corrosion was a concern. The best option was 22GA (.030) 304 Stainless Steel, which provided the optimal hardness properties and corrosion resistance needed for job. The blueprint called for 0.9mm/.0354" round holes. The Hendrick team knew this wasn't going to be a standard manufacturing operation. The recommended industry practice for perforating stainless steel requires a hole diameter to be 1.5 times bigger than the gauge thickness. The designated hole sizes were the same diameter as the

material thickness which would cause punch breakage and distortion of the panel.

To avoid punch breakage, Hendrick's manufacturing team developed a cluster punch tool. After testing the punch using several different manufacturing methods, the team found success.

Once the extrusion screen was successfully manufactured, it went through one more design evolution to improve the customer's extrusion quality. Extrusion rejects were occurring due to support bars on the equipment behind the screen. They partially blocked holes, causing the rejects. Hendrick modified the hole pattern on the screen by adding margins to match the support bar locations. This successfully eliminated the extrusion rejects and improved yield.
